FOWLERVILLE COMMUNITY SCHOOLS

Fowlerville K-2 Elementary: Project Activities

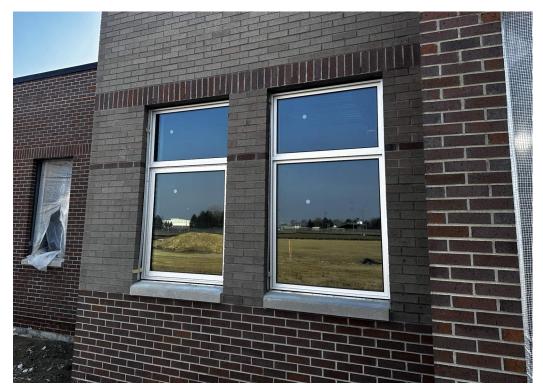
Exterior view of windows.

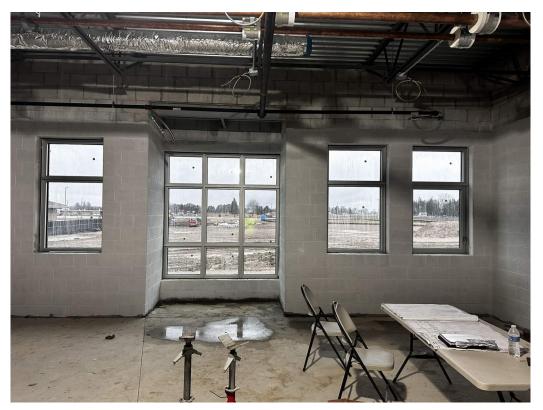
Windows installed and block filler on walls.

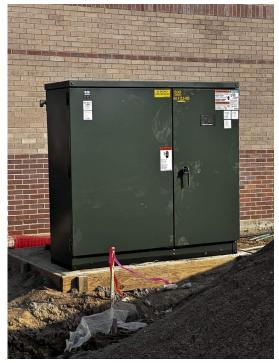
Transformer installed.

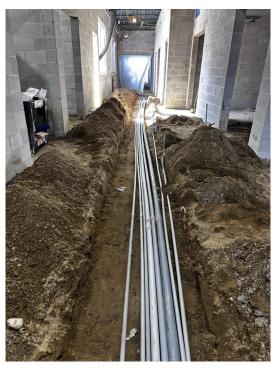
Electrical conduit install in hallway.

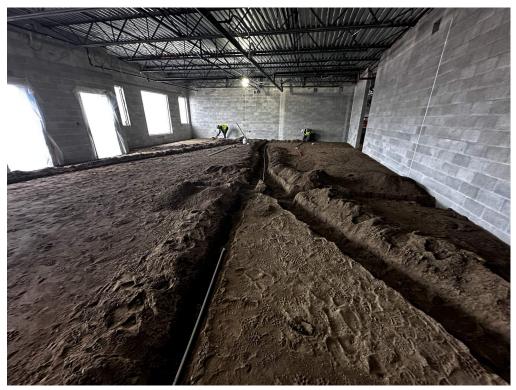
Electrical conduit installed in sand prior to concrete on east side of building.

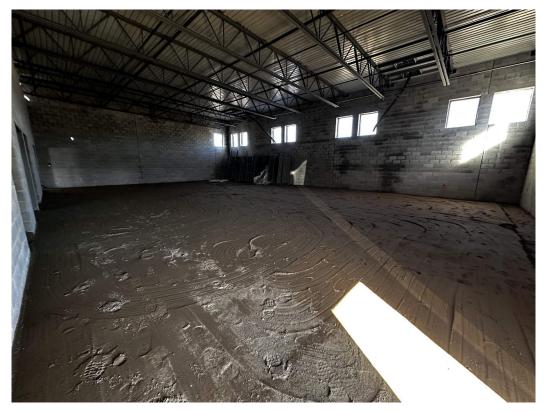
Sand prep prior to concrete in a classroom.

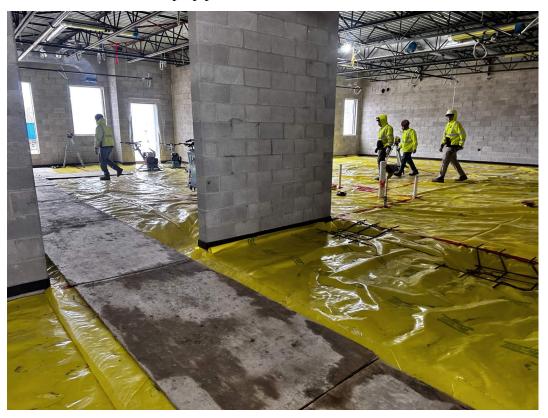
Vapor barrier preparation prior to concrete in a classroom.

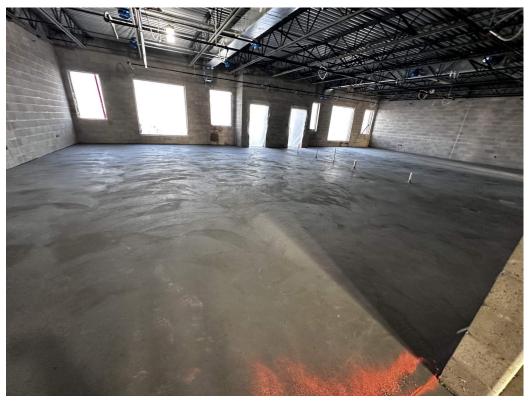
Concrete while curing in a classroom.

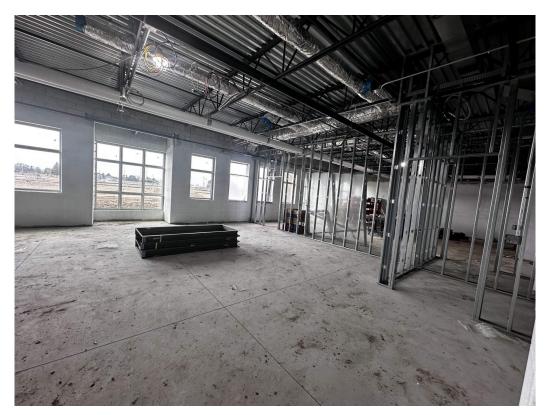
Concrete and wall framing in a classroom.
